Developmental stages of the underwater bait setting chute for the pelagic longline fishery

CONSERVATION ADVISORY SCIENCE NOTES: 246

Molloy, Walsh, Barnes

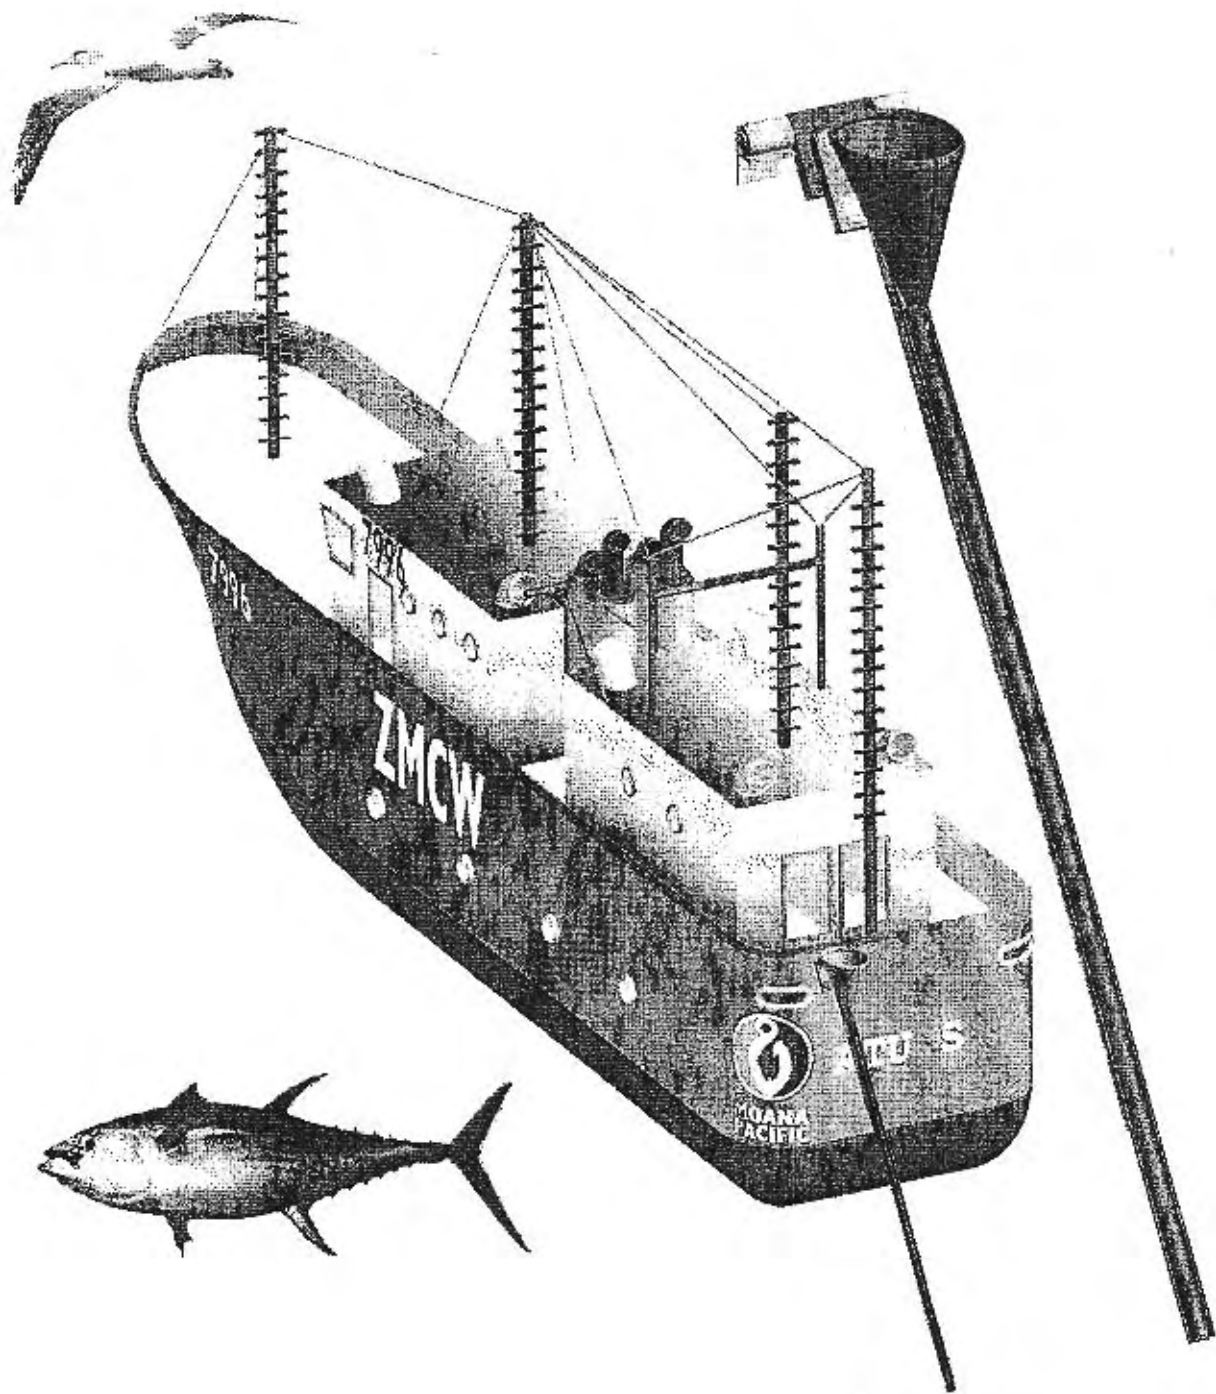
FRONTISPIECE. DIAGRAM OF AN UNDERWATER BAIT SETTING CHUTE IN PLACE ON A PELAGIC FISHING VESSEL.

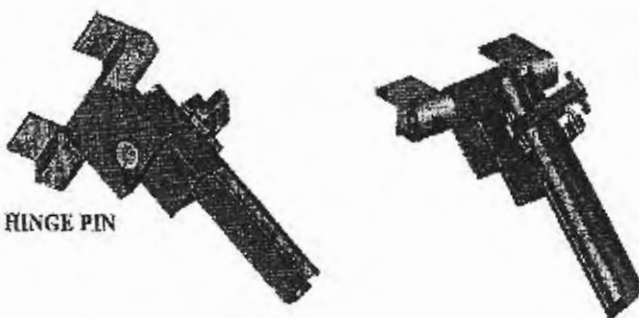
FIGURE 4. SPLIT COLLAR SYSTEM FOR SECURING THE CHUTE IN POSITION.

The chute was attached to the vessel 1.5 metres off the port quarter at the stern of the vessel. A base plate and hinge assembly was used to attach it to the stern. The hinge assembly operated through two arcs (Figure 3). One hinge pin was used to enable the chute to swing to port and starboard, and another to allow the chute to swing toward and away from the vessel. When the chute was fully deployed or recovered, a locking pin secured it in position (Figure 4). A hinged retaining arm secured the chute in the split collar during recovery and deployment.

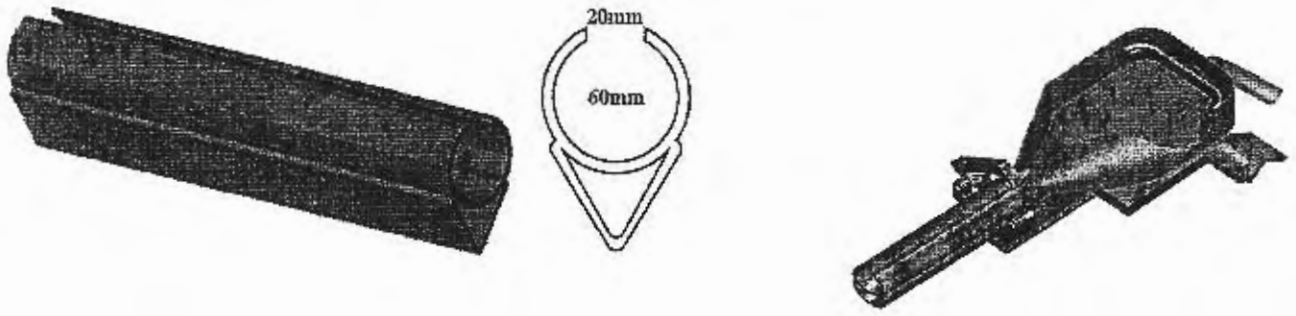
FIGURE 6. (ABOVE LEFT) CHUTE DESIGN AND (RIGHT) TROUGH USED ON F.V. *BRENDA KAY*.

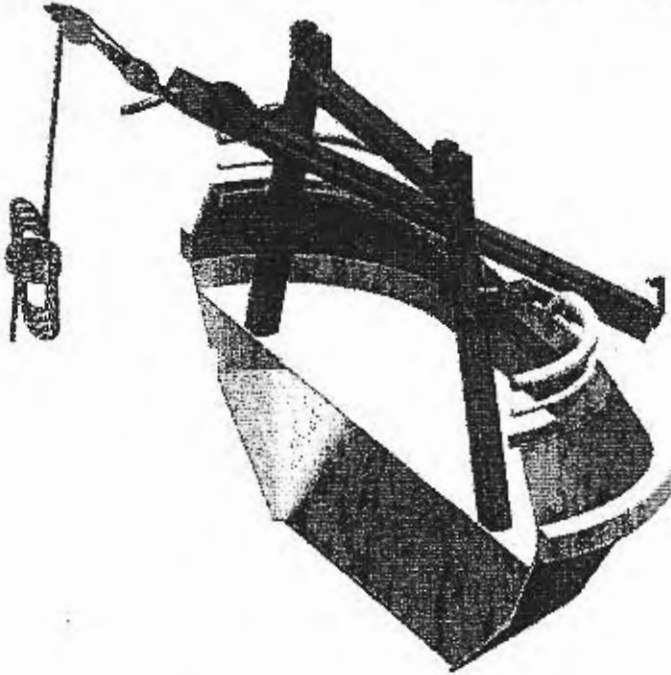
FIGURE 7. DEPLOYMENT AND RETRIEVAL SYSTEM USED ON F.V. *BRENDA KAY*. THE HOISTING GEAR WAS ATTACHED TO THE MAST ABOVE THE WHEELHOUSE. AN EXISTING GANTRY ON THE VESSEL CAUSED SOME OBSTRUCTION TO THE CHUTE.

The chute configuration used on the F.V. *Brenda Kay* is shown in Figures 7 and 8. The retrieval system used for the trials consisted of one double block shackled to the vessel's mast approximately 6.5 metres above the water line. A single block with a shackle was connected to a lug at the base of the chute feed trough. An 8 mm three-strand rope was laced between two blocks and rigged to advantage; this block configuration is known as a "Handy Billy" or "Jigger".

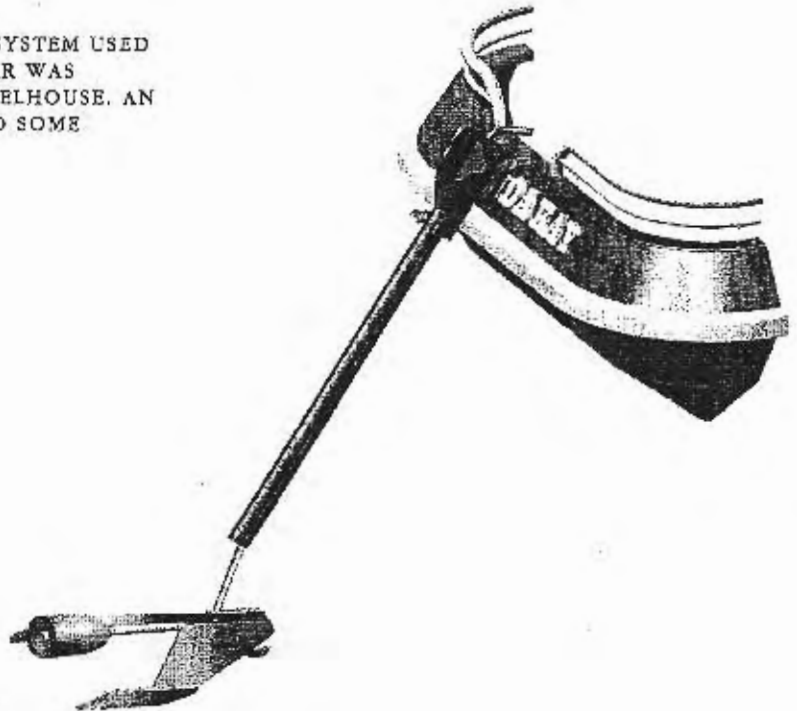
FIGURE 8. CHUTE IN USE ON F.V. *BRENDA KAY*. THE HANDRAIL HAD TO BE RECESSED TO ALLOW FOR IT.

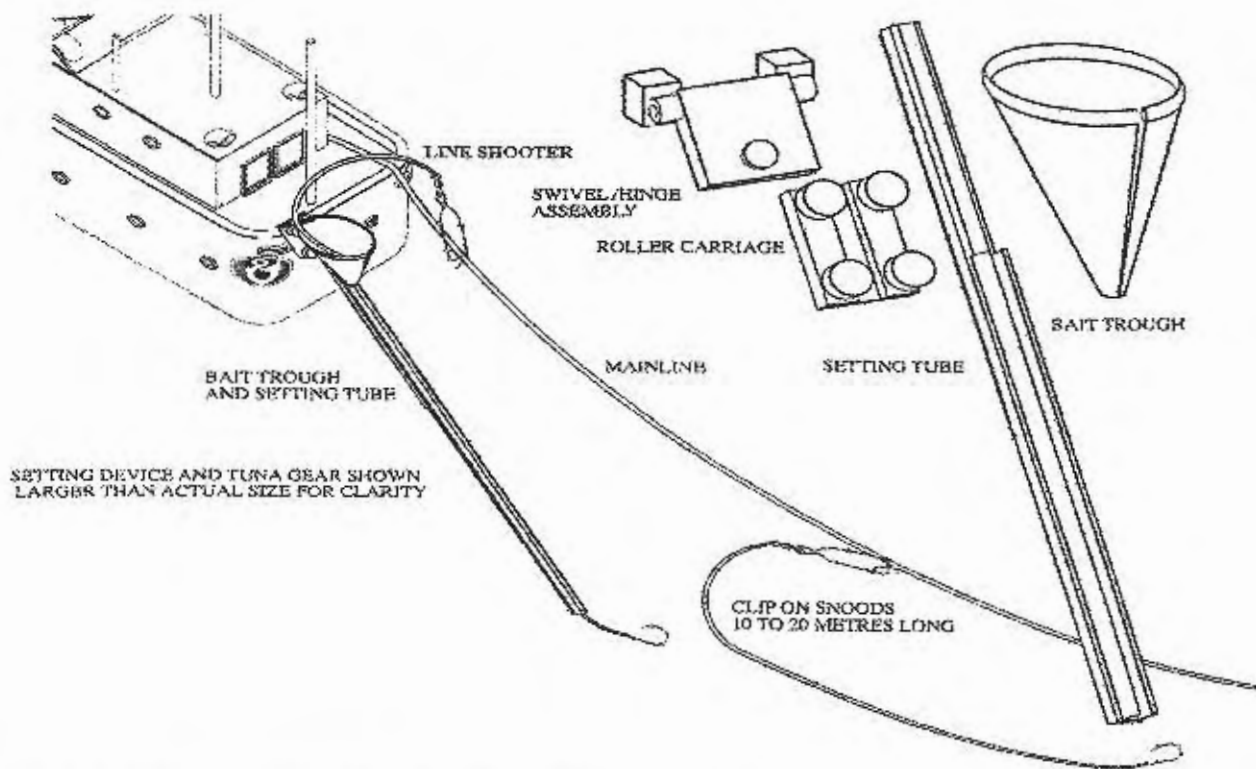
FIGURE 9. UNDERWATER SETTING CHUTE IN USE ON F.V. ATU S.

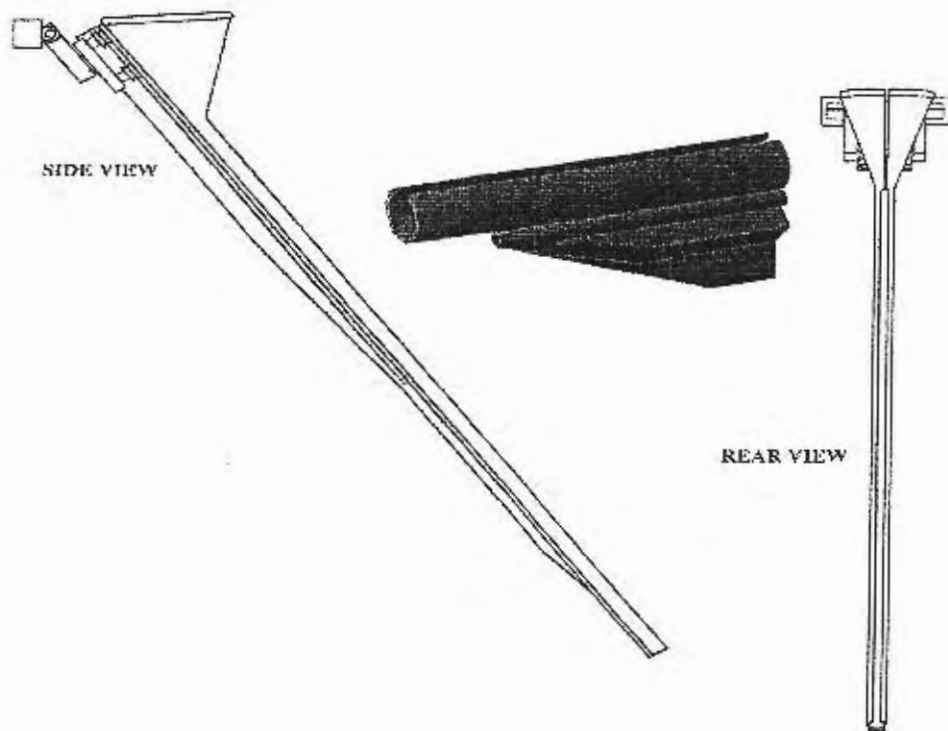
FIGURE 10. VIEWS OF THE CHUTE.

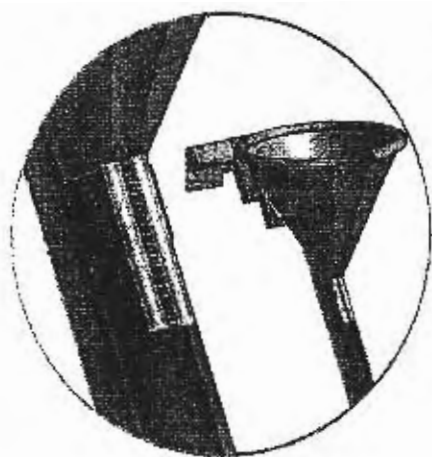
FIGURE 11. (LEFT) VIEW OF BRUSHES AT TOP OF CHUTE AND (RIGHT) DETAIL OF TROUGH.

Two horizontally opposed and partially overlapping brushes were added to the top section of the chute (Figure 11) to retain the snood inside the chute until the force from the mainline pulling the other end of the snood released it from the chute.

A conical trough was used. This had a piece of pipe around the top edge to carry the water to a series of holes placed at 50 mm intervals around the inside perimeter (Figure 11). This was designed to ensure an even water flow inside the trough to help align the bait for entry into the neck of the chute. Unlike earlier designs, this trough was detachable from the chute. A slight curve on the mainline side of the trough was to prevent the traces becoming snagged on any corners.

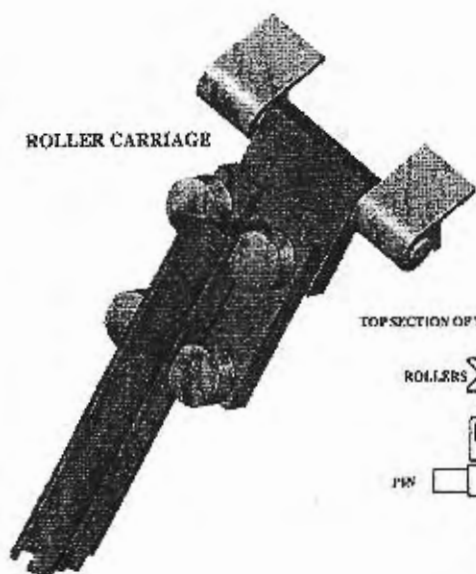
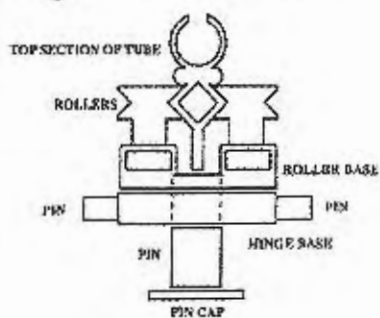
FIGURE 12. DETAIL OF ROLLER CARRIAGE SYSTEM FOR DEPLOYING AND RETRIEVING THE CHUTE.

The double hook is designed to be able to pass completely through the roller carriage, and is connected and disconnected with a steel gaff while above it.

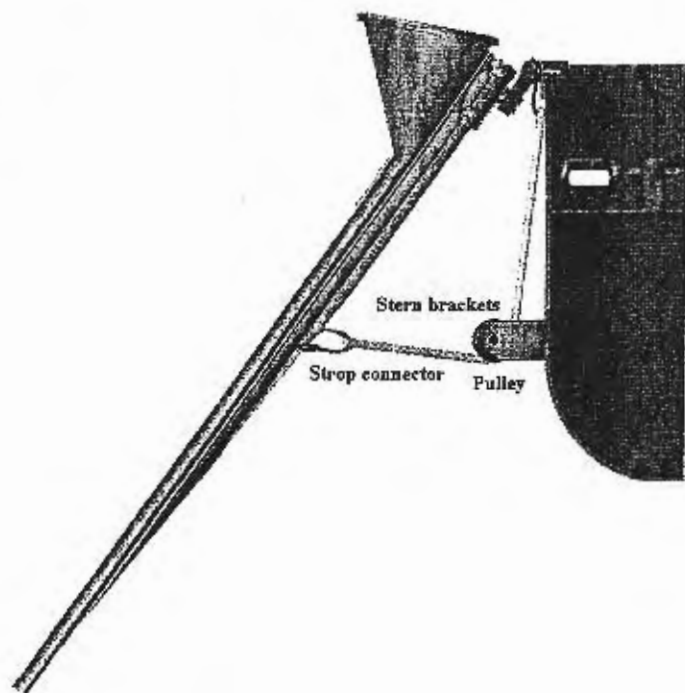
FIGURE 13. STROP ATTACHMENT USED TO CONTROL THE ANGLE OF THE CHUTE.

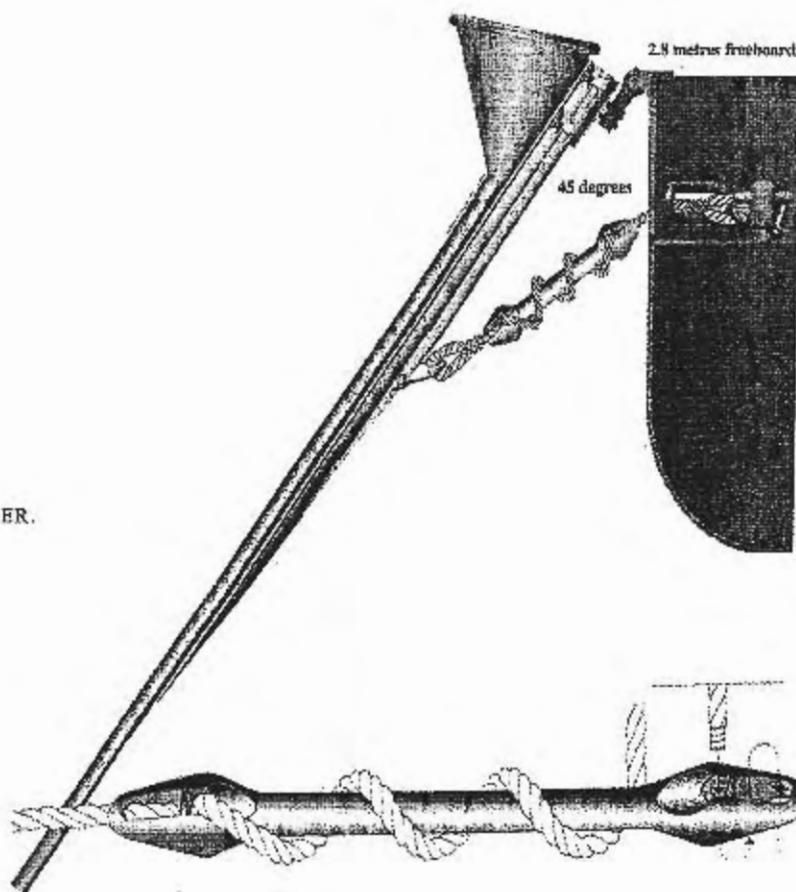
FIGURE 15. VIEW OF THE SHOCK ABSORBER.

The elasticity of the Forsheda mooring compensator deteriorated over the four sets and this reduced the setting angle and depth of the chute. On the first set the bait exit point was consistently deeper than 3 metres, but by the fourth set the depth of the bait exit point had reduced to around 2 metres.

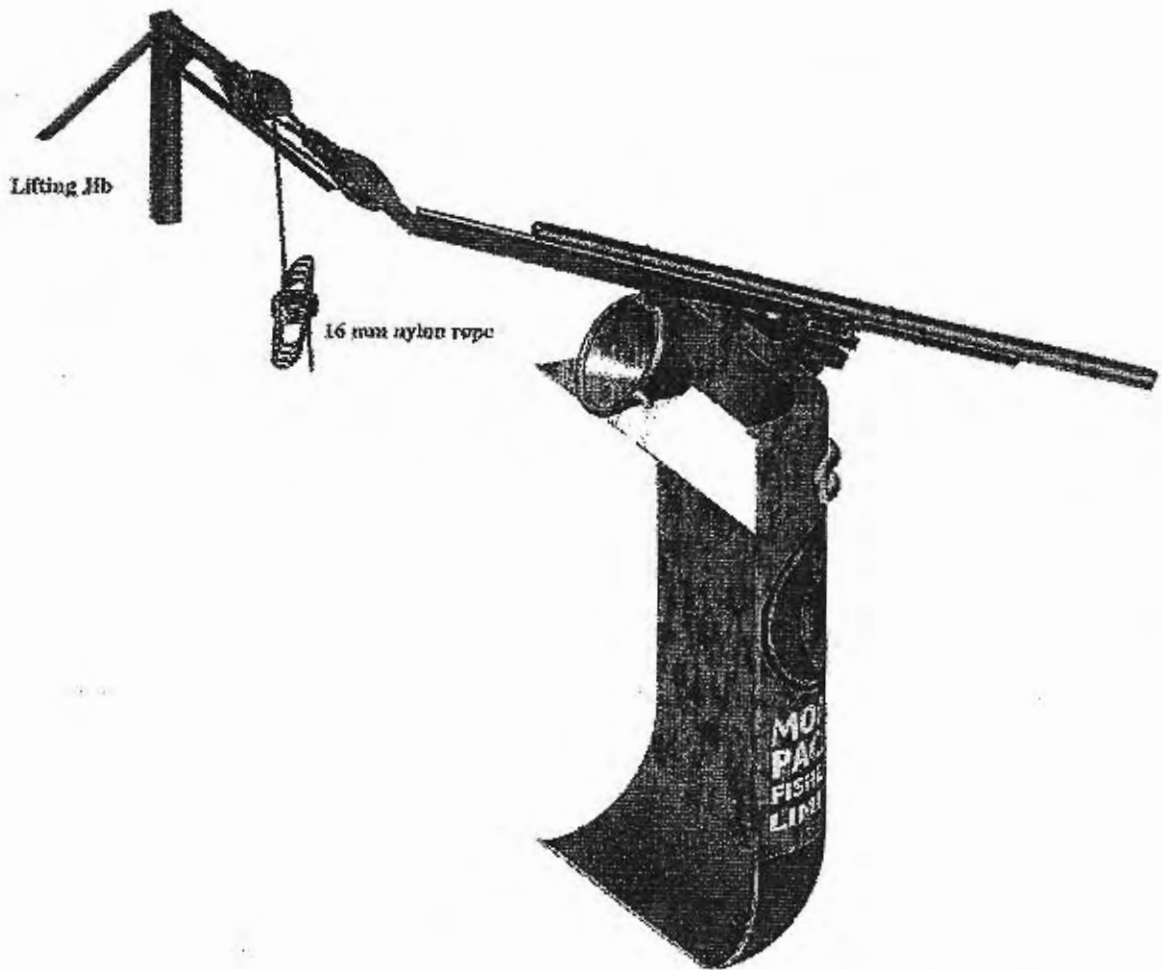
FIGURE 16. SECOND METHOD OF DEPLOYMENT AND RECOVERY OF THE CHUTE TRIALED ON F.V. *ATU S.*

One double sheave and one single sheave block were used for recovery and deployment of a 9.5 m device (see Figure 16). The lifting jib was mounted on top of the stern cabins. It was positioned to be as in-line as possible with the streaming position of the setting tube. This allowed the chute to be drawn up to a point beyond the balance point of the tube on the roller carriage/hinge assembly. Once the tube had been drawn up past the section that located the chute in the rollers, it could be lifted clear of them. The quick-release clip attaching the shock connector to the chute was released during recovery and connected during deployment. The trough clipped on and off during these procedures.

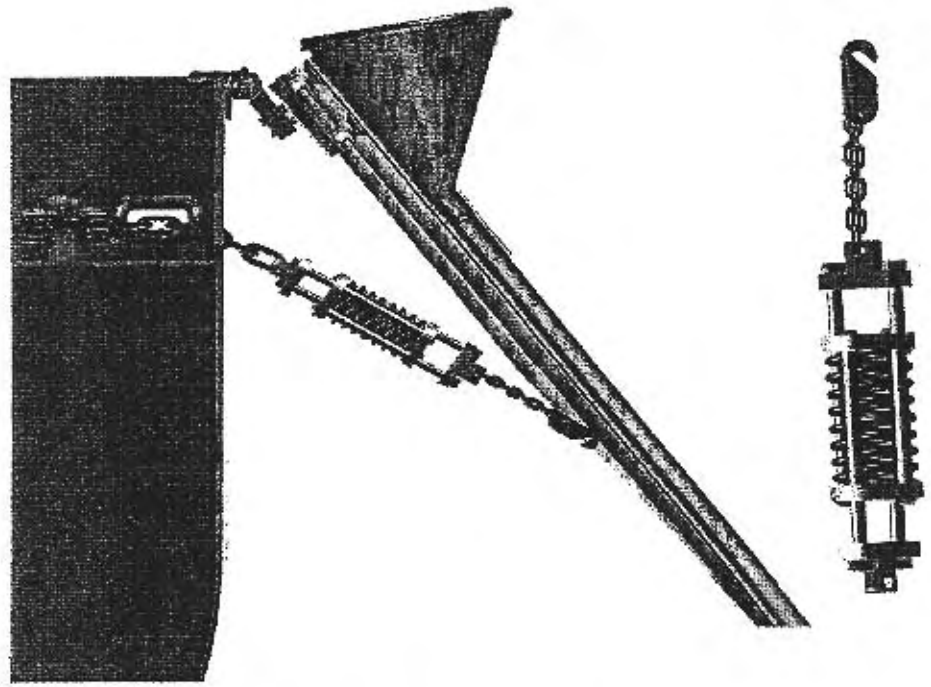
FIGURE 18. SPRING SHOCK ABSORBER CONNECTED TO THE CHUTE.

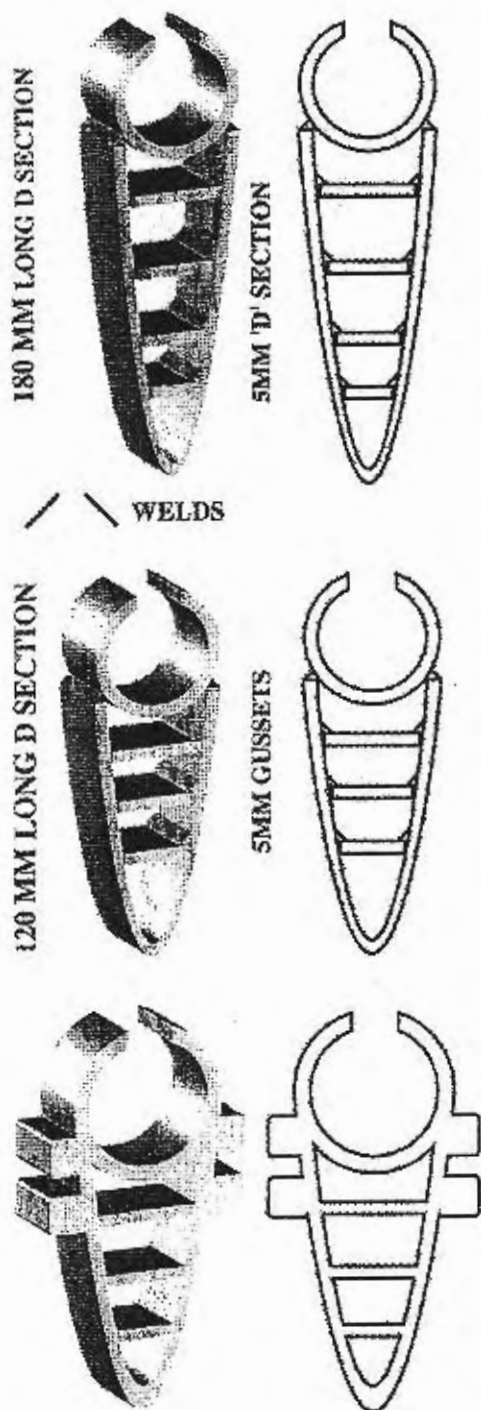
FIGURE 20. PROPOSED IMPROVED CROSS-SECTIONS TO THE CHUTE.

It may be economically viable to extrude the device from aluminium (Figure 20). A stainless steel liner could be used to protect the inside of the setting tube from the points of the hooks, and lead weights could be used to adjust the setting angle.
